**Flood Control Project Maintenance
Levee Inspections**

Maintenance Issue Types Only, Levee Inspection Report By Mile - Spring 2017

Reclamation District No. 0563 Tyler Island

Waterway	Bank	Unit Miles	Inspection Start/End	Inspector
Unit No. 01 Georgiana Slough (Tyler Island)	Left	12.11	03/14/2017 03/16/2017	Richard Willoughby

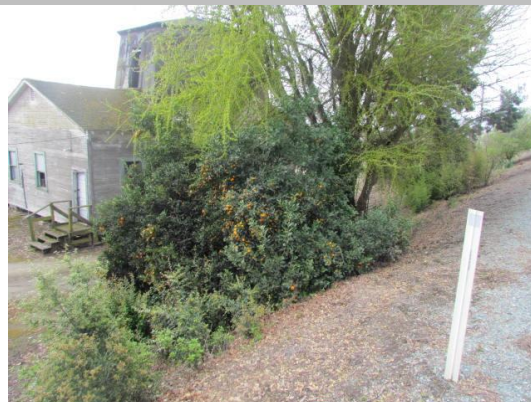
Photo 1 of 1 : SP_2017_RD0563_210_28_20170313_00024.jpg

LM Start	0.12	Rating **	M	Issue No.	28	
LM End	0.14	Issue Type +	Ma	Location *	LS	
Category	Earthen Levee			GPS Latitude/Longitude		
				Start		End
Item	Trim / Thin Trees			38.233910 °		38.233655 °
				-121.518722 °		-121.519000 °
DWR ID	DWR_RD0563_01_s_2012_28					
Comment Code						
T1 : Trim trees to at least five feet above ground level.						
Inspector Comment

Looking southeast at landscaping on landside slope and toe.

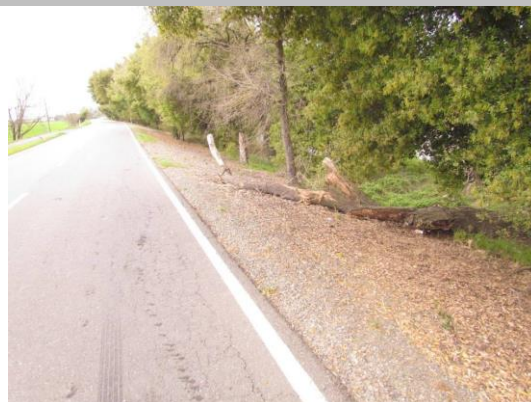
Photo 1 of 2 : SP_2017_RD0563_210_32_20170316_00235.jpg

LM Start	0.17	Rating **	M	Issue No.	32
LM End	0.17	Issue Type +	Ma	Location *	WS
Category	Earthen Levee			GPS Latitude/Longitude	
				Start	End
Item	Encroachments			38.233315 °	38.233315 °
				-121.519360 °	-121.519360 °
DWR ID	DWR_RD0563_01_s_2012_32				
Comment Code					
TR : Tree or limb					
Inspector Comment					
Tree fallen across waterward slope.

Looking downstream at tree branch on waterward slope. (Spring 2017)

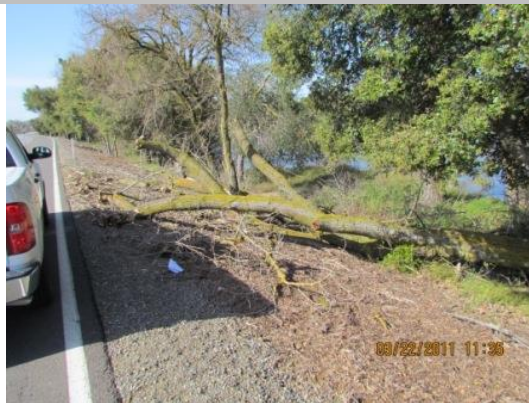
Photo 2 of 2 : SP_2017_RD0563_210_32_20170313_00027.jpg

LM Start	0.17	Rating **	M	Issue No.	32 (cont)
LM End	0.17	Issue Type +	Ma	Location *	WS
Category	Earthen Levee			GPS Latitude/Longitude	
				Start	End
Item	Encroachments			38.233315 °	38.233315 °
				-121.519360 °	-121.519360 °
DWR ID	DWR_RD0563_01_s_2012_32				
Comment Code					
TR : Tree or limb					
Inspector Comment					
Tree fallen across waterward slope.

Looking downstream at fallen tree limb on waterside slope. (Spring 2016)

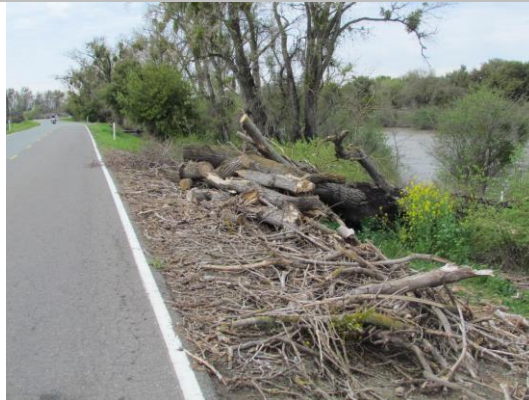
Photo 1 of 1 : SP_2017_RD0563_210_119_20170316_00236.jpg

LM Start	0.40	Rating **	U	Issue No.	119
LM End	0.40	Issue Type +	Ma	Location *	WS
Category	Earthen Levee			GPS Latitude/Longitude	
				Start	End
Item	Encroachments			38.230750 °	38.230750 °
				-121.521997 °	-121.521997 °
DWR ID	DWR_RD0563_01_s_2017_119				
Comment Code					
TR : Tree or limb					
Inspector Comment					
Large fallen tree pruning piles on waterward slope should be discard.

Looking south at pruning pile on waterward shoulder and slope.

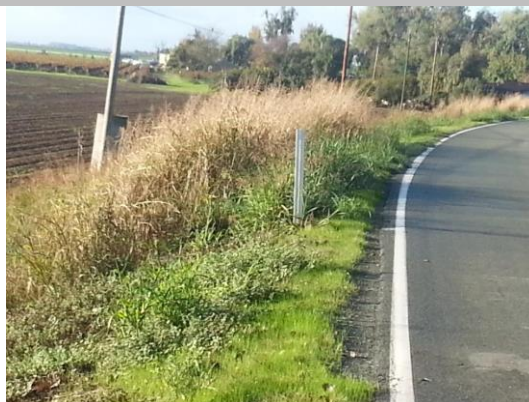
Photo 1 of 2 : SP_2017_RD0563_210_138_20170313_00113.jpg

LM Start	0.49	Rating **	A/W	Issue No.	138
LM End	0.65	Issue Type +	Ma	Location *	LS
Category	Earthen Levee			GPS Latitude/Longitude	
				Start	End
Item	Vegetation			38.229787 °	38.228094 °
				-121.523001 °	-121.525188 °
DWR ID	DWR_RD0563_01_f_2015_138				
Comment Code					
V2 : Remove the wild growth other than native grasses from the levee slopes.					
Inspector Comment					
Dense johnson grasses on landward slope.

Looking west at dense veg on landward slope.

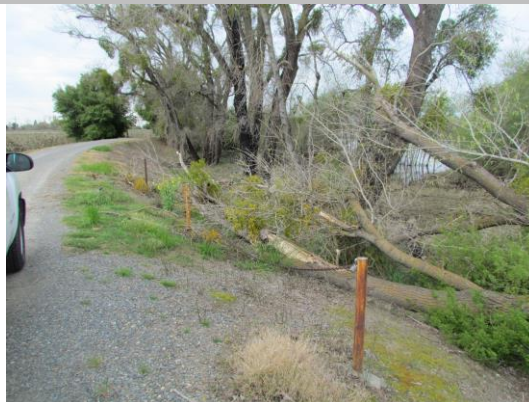
Photo 1 of 1 : SP_2017_RD0563_210_120_20170316_00237.jpg

LM Start	0.87	Rating **	M	Issue No.	120
LM End	0.87	Issue Type +	Ma	Location *	WS
Category	Earthen Levee			GPS Latitude/Longitude	
				Start	End
Item	Encroachments			38.225488 °	38.225488 °
				-121.526838 °	-121.526838 °
DWR ID	DWR_RD0563_01_s_2017_120				
Comment Code					
TR : Tree or limb					
Inspector Comment					
Fallen tree on waterward slope.

Looking southwest at fallen tree on waterward slope.

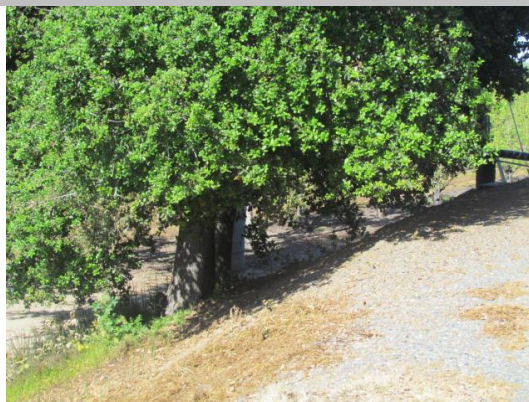
Photo 1 of 1 : SP_2017_RD0563_210_755_20170313_00144.jpg

LM Start	0.92	Rating **	U	Issue No.	755
LM End	0.92	Issue Type +	Ma	Location *	LS
Category	Earthen Levee			GPS Latitude/Longitude	
				Start	End
Item	Trim / Thin Trees			38.225549 °	38.225549 °
				-121.527658 °	-121.527658 °
DWR ID	DWR_RD0563_01_s_2015_755				
Comment Code					
T1 : Trim trees to at least five feet above ground level.					
Inspector Comment

Looking southeast at untrimmed tree on landward slope.

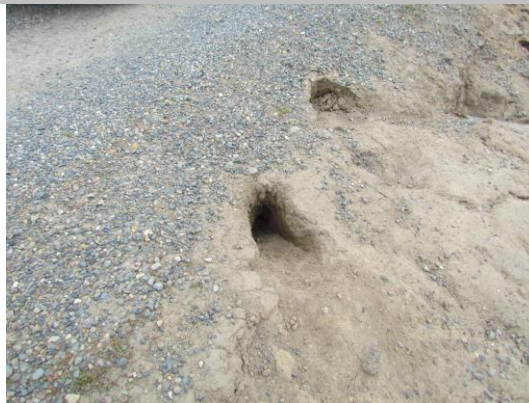
Photo 1 of 1 : SP_2017_RD0563_210_121_20170316_00238.jpg

LM Start	0.95	Rating **	U	Issue No.	121
LM End	0.95	Issue Type +	Ma	Location *	LS
Category	Earthen Levee			GPS Latitude/Longitude	
				Start	End
Item	Animal Control			38.225808 °	38.225808 °
				-121.528197 °	-121.528197 °
DWR ID	DWR_RD0563_01_s_2017_121				
Comment Code					
A1 : Exterminate rodents and backfill and compact or grout burrows.					
Inspector Comment					
Several large rodent holes on landward slope.

Looking at typical rodent hole within this reach.

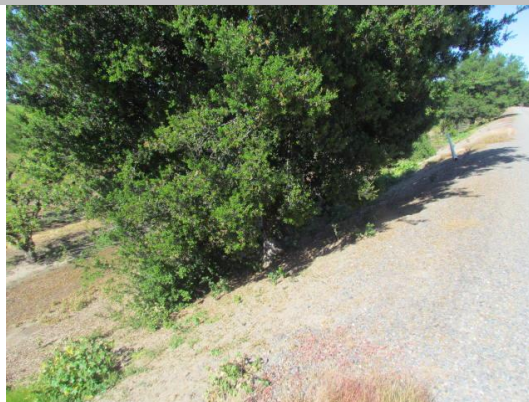
Photo 1 of 1 : SP_2017_RD0563_210_756_20170313_00145.jpg

LM Start	0.98	Rating **	U	Issue No.	756
LM End	0.98	Issue Type +	Ma	Location *	LS
Category	Earthen Levee			GPS Latitude/Longitude	
				Start	End
Item	Trim / Thin Trees			38.226011 °	38.226011 °
				-121.528524 °	-121.528524 °
DWR ID	DWR_RD0563_01_s_2015_756				
Comment Code					
T1 : Trim trees to at least five feet above ground level.					
Inspector Comment

Looking southeast at untrimmed tree on landward slope.

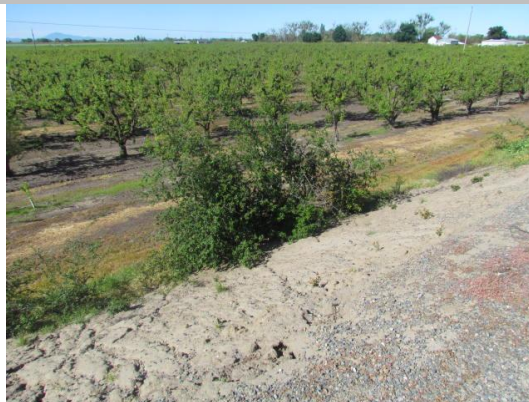
Photo 1 of 1 : SP_2017_RD0563_210_132_20170313_00109.jpg

LM Start	0.99	Rating **	M	Issue No.	132
LM End	0.99	Issue Type +	Ma	Location *	LS
Category	Earthen Levee			GPS Latitude/Longitude	
				Start	End
Item	Trim / Thin Trees			38.226149 °	38.226149 °
				-121.528789 °	-121.528789 °
DWR ID	DWR_RD0563_01_s_2016_132				
Comment Code					
T1 : Trim trees to at least five feet above ground level.					
Inspector Comment					
Small trees on landward shoulder be removed.

Looking southeast at several small trees at landward toe.

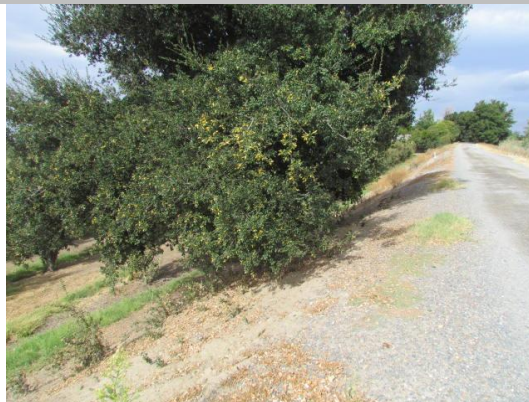
Photo 1 of 1 : SP_2017_RD0563_210_757_20170313_00146.jpg

LM Start	1.01	Rating **	M	Issue No.	757
LM End	1.01	Issue Type +	Ma	Location *	LS
Category	Earthen Levee			GPS Latitude/Longitude	
				Start	End
Item	Trim / Thin Trees			38.226294 °	38.226294 °
				-121.529055 °	-121.529055 °
DWR ID	DWR_RD0563_01_s_2015_757				
Comment Code					
T1 : Trim trees to at least five feet above ground level.					
Inspector Comment

Looking at untrimmed trees on landward slope.

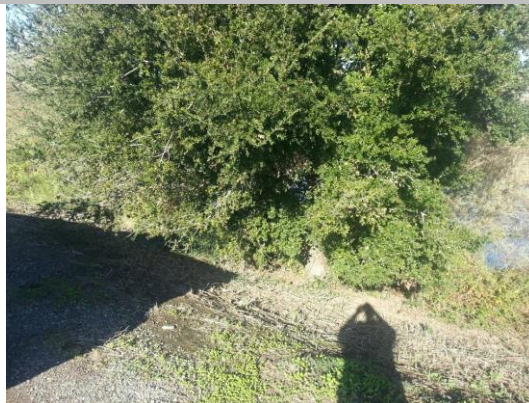
Photo 1 of 1 : SP_2017_RD0563_210_760_20170313_00148.jpg

LM Start	1.48	Rating **	U	Issue No.	760
LM End	1.48	Issue Type +	Ma	Location *	WS
Category	Earthen Levee			GPS Latitude/Longitude	
				Start	End
Item	Trim / Thin Trees			38.223835 °	38.223835 °
				-121.535605 °	-121.535605 °
DWR ID	DWR_RD0563_01_s _ 2015_760				
Comment Code					
T1 : Trim trees to at least five feet above ground level.					
Inspector Comment

Looking upstream at untrimmed tree on waterward slope.

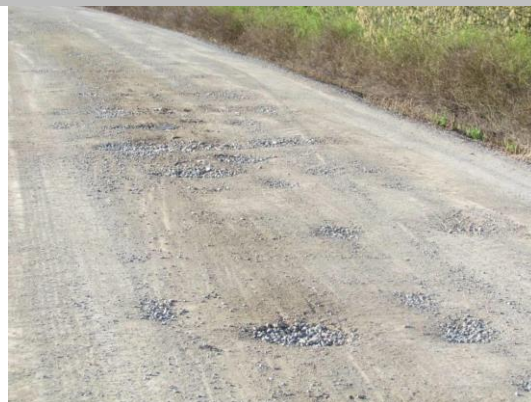
Photo 1 of 1 : SP_2017_RD0563_210_66_20170316_00244.jpg

LM Start	2.33	Rating **	M	Issue No.	66
LM End	3.65	Issue Type +	Ma	Location *	CR
Category	Earthen Levee			GPS Latitude/Longitude	
				Start	End
Item	Crown Surface / Depressions / Rutting			38.216733 °	38.203056 °
				-121.541672 °	-121.539749 °
DWR ID	DWR_RD0563_01_s_2013_66				
Comment Code					
C3 : Add appropriate gravel or road base. Grade and compact.					
Inspector Comment					
The roadway is passable, but should be bladed to maintain a good roadway with good gravel and a smooth surface. Some material may need to be added.

Looking south at several potholes/ruts on levee crown.

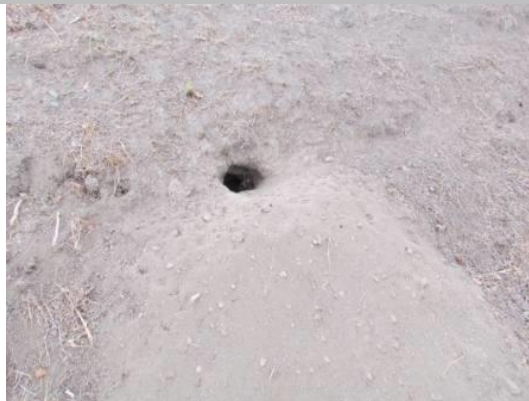
Photo 1 of 4 : SP_2017_RD0563_210_85_20170313_00081.jpg

LM Start	2.53	Rating **	M	Issue No.	85 (cont)
LM End	2.55	Issue Type +	Ma	Location *	LS

Looking west at rodent hole on landside slope.

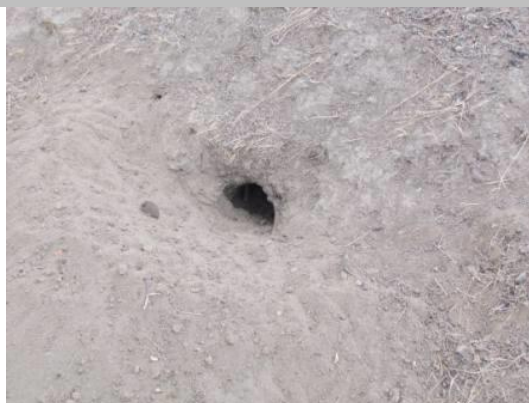
Photo 2 of 4 : SP_2017_RD0563_210_85_20170313_00082.jpg

Looking east at rodent hole on landside slope.

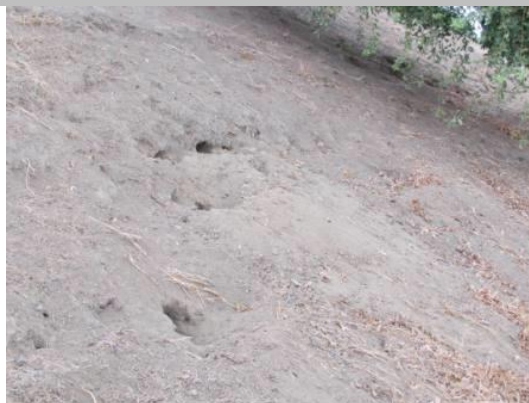
Photo 4 of 4 : SP_2017_RD0563_210_85_20170313_00084.jpg

LM Start	2.53	Rating **	M	Issue No.	85 (cont)	
LM End	2.55	Issue Type +	Ma	Location *	LS	
Category	Earthen Levee			GPS Latitude/Longitude		
				Start		End
Item	Animal Control			38.215082 °		38.214852 °
				-121.538652 °		-121.538305 °
DWR ID	DWR_RD0563_01_s_2012_85					
Comment Code						
A3 : No rodents visible, but rodent burrows visible; need to backfill and compact or grout burrows.						
Inspector Comment						
Rodent holes not visible due to dense veg on landward slope.

Looking northeast at rodent holes on landside slope.

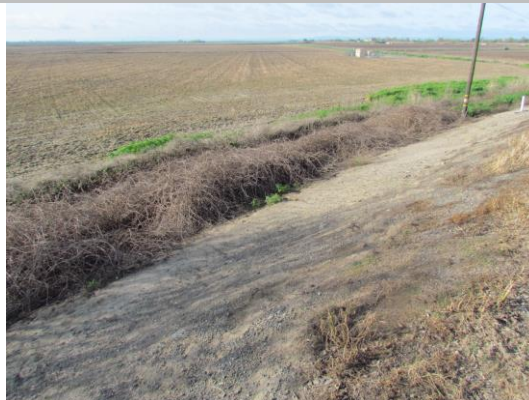
Photo 1 of 2 : SP_2017_RD0563_210_67_20170316_00249.jpg

LM Start	2.93	Rating **	U	Issue No.	67
LM End	2.95	Issue Type +	Ma	Location *	LS
Category	Earthen Levee			GPS Latitude/Longitude	
				Start	End
Item	Vegetation			38.210472 °	38.210358 °
				-121.535175 °	-121.535478 °
DWR ID	DWR_RD0563_01_s_2012_67				
Comment Code					
V2 : Remove the wild growth other than native grasses from the levee slopes.					
Inspector Comment					
Dead Vines (Berry or wildroses) on landside toe.

Looking east at dead berryvines at landward toe. (Spring 2017)

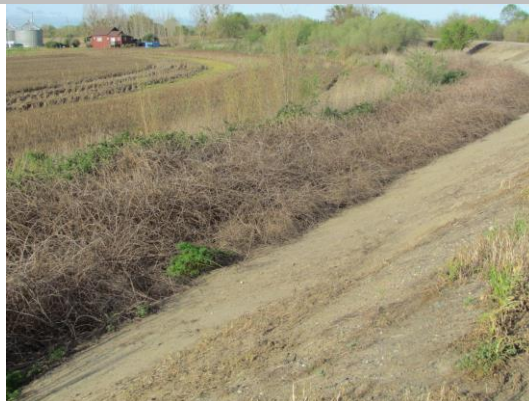
Photo 1 of 3 : SP_2017_RD0563_210_74_20170316_00250.jpg

LM Start	3.02	Rating **	U	Issue No.	74
LM End	3.21	Issue Type +	Ma	Location *	LS
Category	Earthen Levee			GPS Latitude/Longitude	
				Start	End
Item	Vegetation			38.210212 °	38.209165 °
				-121.536728 °	-121.539920 °
DWR ID	DWR_RD0563_01_s_2012_74				
Comment Code					
V2 : Remove the wild growth other than native grasses from the levee slopes.					
Inspector Comment					
Dead berryvines at landside toe blocking view of toe.

Looking southeast at dead berryvines along landward toe and berm. (Spring 2017)

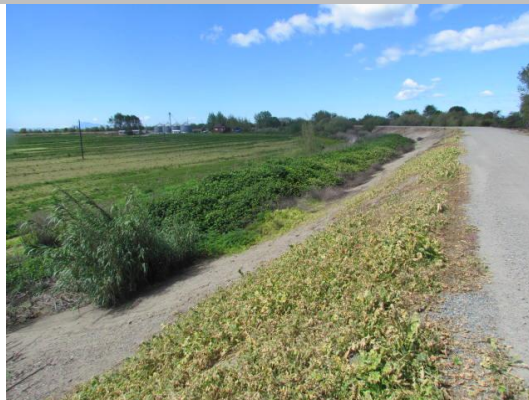
Photo 2 of 3 : SP_2017_RD0563_210_74_20170313_00059.jpg

Looking southeast at berryvines at landward toe., (Spring 2016)

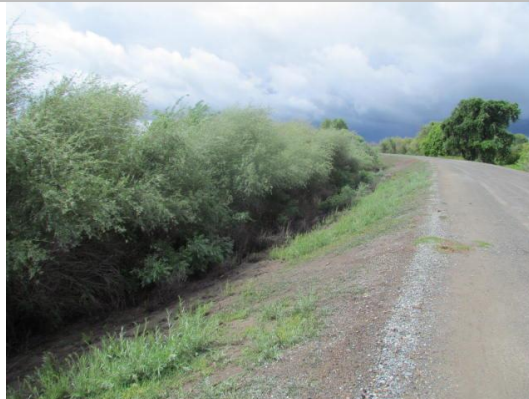
Photo 2 of 2 : SP_2017_RD0563_210_763_20170313_00150.jpg

LM Start	3.11	Rating **	U	Issue No.	763 (cont)	
LM End	3.21	Issue Type +	Ma	Location *	LS	
Category	Earthen Levee			GPS Latitude/Longitude		
				Start		End
Item	Vegetation			38.210005 °		38.209229 °
				-121.538452 °		-121.539855 °
DWR ID	DWR_RD0563_01_s_2015_763					
Comment Code						
V2 : Remove the wild growth other than native grasses from the levee slopes.						
Inspector Comment						
Dense vegetation (willows) at landward toe.

Looking south at dense vegetation at landward slope and toe. (Spring 2015)

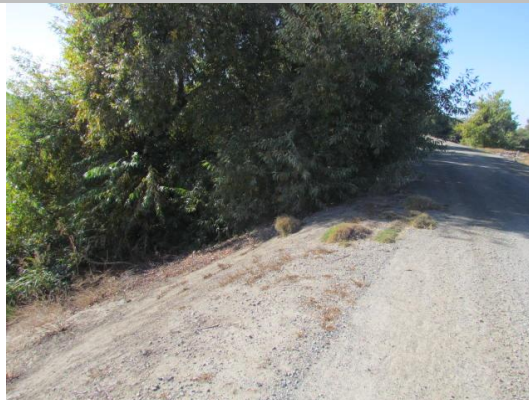
Photo 1 of 2 : SP_2017_RD0563_210_68_20170313_00053.jpg

LM Start	3.21	Rating **	U	Issue No.	68
LM End	3.21	Issue Type +	Ma	Location *	LS
Category	Earthen Levee			GPS Latitude/Longitude	
				Start	End
Item	Trim / Thin Trees			38.209217 °	38.209217 °
				-121.539823 °	-121.539823 °
DWR ID	DWR_RD0563_01_s_2012_68				
Comment Code					
T2 : Thin trees to allow visibility of the ground and room to flood fight.					
Inspector Comment

Looking south at dense trees on landward slope.

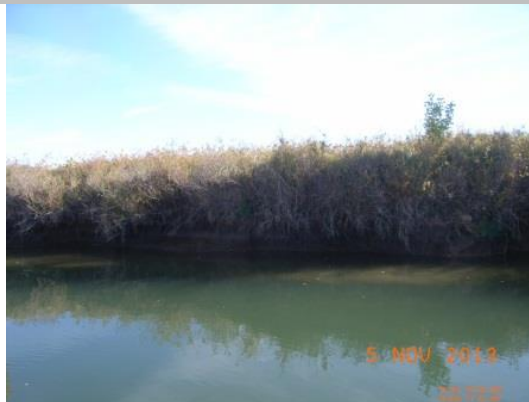
Photo 1 of 1 : SP_2017_RD0563_210_45_20170313_00038.jpg

LM Start	4.98	Rating **	M	Issue No.	45
LM End	5.04	Issue Type +	Ma	Location *	WS
Category	Supplemental			GPS Latitude/Longitude	
				Start	End
Item	2015 USACE Erosion Survey, DRAFT			38.190073 °	38.189524 °
				-121.556307 °	-121.557227 °
DWR ID	DWR_RD0563_01_s_2016_45				
Comment Code					
Inspector Comment					
2009 - Small scallops of erosion into the levee toe behind brush boxes. 2011 - Minor new erosion. 2012 - Site extended upstream to account for addition erosion pockets. 2015: Last observed in 2013. [2015 Site ID: GEO_7-2_L]

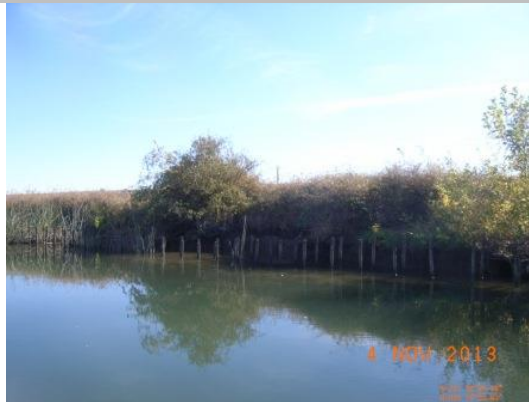
Photo 1 of 1 : SP_2017_RD0563_210_55_20170313_00044.jpg

Comment Code					
Inspector Comment					
1997 - Deep pockets of erosion and narrow berm. Reach is characterized by lots of pockets into the existing berm and/or levee slope. 1999 - Some pockets filled with rock riprap. 2000 - Exposed fabric. 2001 - Staked, low fascine walls at bankline. 2002 - New spot of rock at upstream end. Some new brush boxes. 2005 - Some stone sliding off the underlying geotextile fabric. Some new brush bundles in the brush boxes; some with missing bundles. Some boxes too low relative to high tide. 2009 - Minimal new erosion, site length extended. 2010 - New erosion on downstream end, site extended downstream. 2011 - Sites 6.1. 6.4 and 6.6 were combined. New erosion pockets, site extended to include the erosion in between the old sites. 2012 - Rock has been placed in portions of the bank since last year. 2015: Last observed in 2013. [2015 Site ID: GEO_6-3_L]

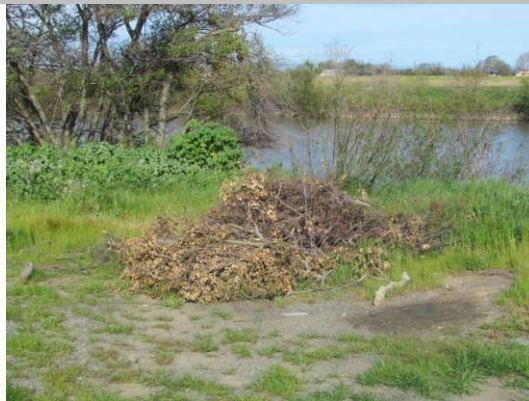
Photo 1 of 1 : SP_2017_RD0563_210_126_20170316_00256.jpg

LM Start	5.88	Rating **	M	Issue No.	126
LM End	5.88	Issue Type +	Ma	Location *	WS
Category	Earthen Levee			GPS Latitude/Longitude	
				Start	End
Item	Encroachments			38.182302 °	38.182302 °
				-121.569232 °	-121.569232 °
DWR ID	DWR_RD0563_01_s_2017_126				
Comment Code					
PR : Prunings					
Inspector Comment					
Prunings stock pile on waterward slope and berm.

Looking west at small pruning pile on waterward slope.

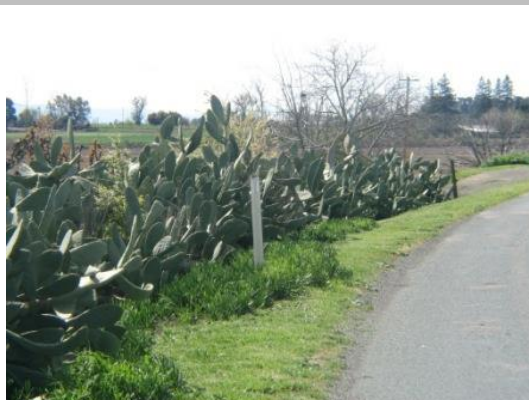
Photo 1 of 2 : SP_2017_RD0563_210_22_20170313_00018.jpg

LM Start	5.92	Rating **	U	Issue No.	22
LM End	5.96	Issue Type +	Ma	Location *	LS
Category	Earthen Levee			GPS Latitude/Longitude	
				Start	End
Item	Vegetation			38.181965 °	38.181763 °
				-121.569913 °	-121.570447 °
DWR ID	DWR_RD0563_01_s_2012_22				
Comment Code					
V2 : Remove the wild growth other than native grasses from the levee slopes.					
Inspector Comment					
Large cactus on landward slope.

Large cactus plant on landward slope from LM 6.04 to 6.08

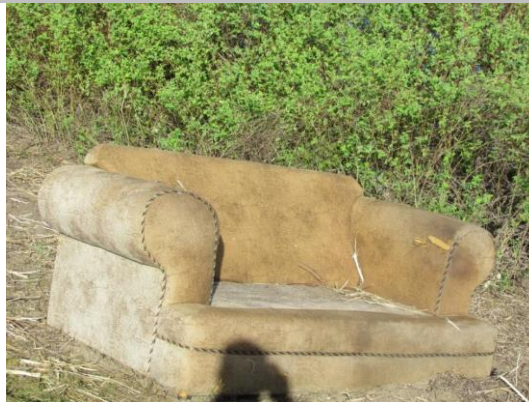
Photo 1 of 1 : SP_2017_RD0563_210_127_20170316_00257.jpg

LM Start	5.98	Rating **	M	Issue No.	127
LM End	5.98	Issue Type +	Ma	Location *	WS
Category	Earthen Levee			GPS Latitude/Longitude	
				Start	End
Item	Encroachments			38.181622 °	38.181622 °
				-121.570887 °	-121.570887 °
DWR ID	DWR_RD0563_01_s_2017_127				
Comment Code					
GA : Garbage					
Inspector Comment					
Sofa on waterward slope.

Looking southwest at sofa on waterward slope.

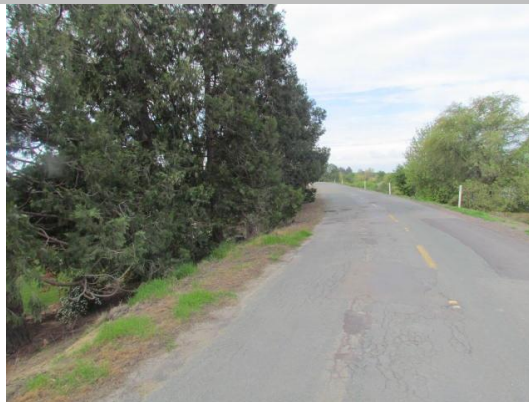
Photo 1 of 1 : SP_2017_RD0563_210_23_20170313_00020.jpg

LM Start	6.26	Rating **	M	Issue No.	23
LM End	6.28	Issue Type +	Ma	Location *	LS
Category	Earthen Levee			GPS Latitude/Longitude	
				Start	End
Item	Trim / Thin Trees			38.181273 °	38.181165 °
				-121.575873 °	-121.576217 °
DWR ID	DWR_RD0563_01_s_2012_23				
Comment Code					
T1 : Trim trees to at least five feet above ground level.					
Inspector Comment

Looking south at trees on landward shoulder.

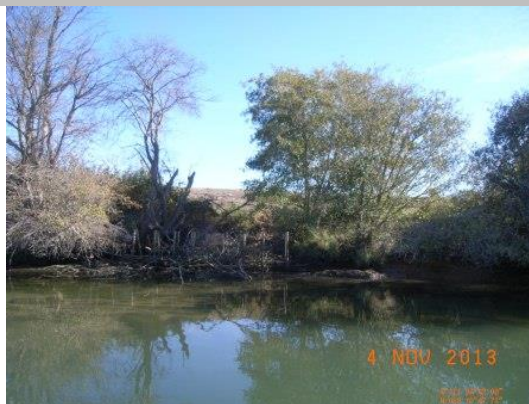
Photo 1 of 1 : SP_2017_RD0563_210_44_20170313_00037.jpg

LM Start	6.38	Rating **	M	Issue No.	44
LM End	6.46	Issue Type +	Ma	Location *	WS
Category	Supplemental			GPS Latitude/Longitude	
				Start	End
Item	2015 USACE Erosion Survey, DRAFT			38.180462 °	38.179319 °
				-121.577895 °	-121.578566 °
DWR ID	DWR_RD0563_01_s_2016_44				
Comment Code					
Inspector Comment					
2013 - Erosion pockets into the levee prism. Erosion pockets primarily located behind unmaintained brush boxes. 2015: Last observed in 2013. [2015 Site ID: GEO_5-8_L]

USACE 2013 Photo #1

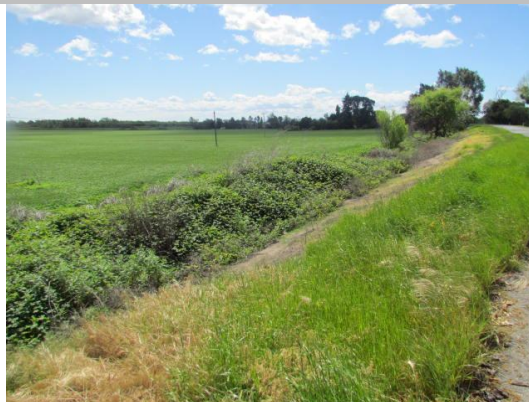
Photo 1 of 1 : SP_2017_RD0563_210_164_20170313_00138.jpg

LM Start	6.59	Rating **	U	Issue No.	164
LM End	6.62	Issue Type +	Ma	Location *	LS
Category	Earthen Levee			GPS Latitude/Longitude	
				Start	End
Item	Vegetation			38.177438 °	38.177033 °
				-121.579151 °	-121.579344 °
DWR ID	DWR_RD0563_01_s_2016_164				
Comment Code					
V2 : Remove the wild growth other than native grasses from the levee slopes.					
Inspector Comment					
Dense vegetation (vines) at landward toe.

Looking east at dense vegetation (vines) at landward toe.

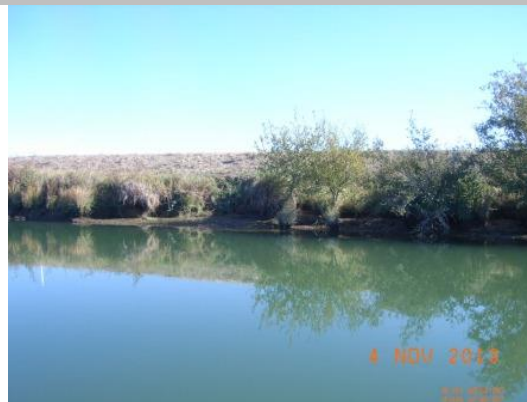
Photo 1 of 1 : SP_2017_RD0563_210_51_20170313_00042.jpg

LM Start	6.64	Rating **	M	Issue No.	51
LM End	7.28	Issue Type +	Ma	Location *	WS
Category	Supplemental			GPS Latitude/Longitude	
				Start	End
Item	2015 USACE Erosion Survey, DRAFT			38.176861 °	38.167959 °
				-121.579747 °	-121.581616 °
DWR ID	DWR_RD0563_01_s_2016_51				
Comment Code					
Inspector Comment					
1997 - Pocket erosion into the toe of the levee. 2000 - Scallops in banks with small colored flags, biotech rolls present. 2001 - Staked, low fascine walls at bankline. 2003 - Still have visibly bad spots, especially at the upstream end. 2005 - Some new brush bundles in the brush boxes; some with missing bundles. Some boxes too low relative to high tide. 2010 - Site extended upstream. 2011 - Minor new erosion. 2015: Last observed in 2013. [2015 Site ID: GEO_5-3_L]

USACE 2013 Photo #1

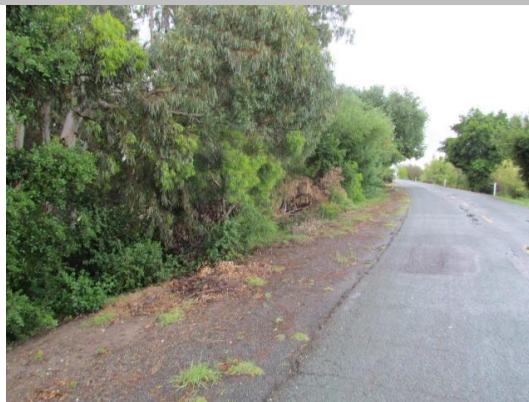
Photo 1 of 1 : SP_2017_RD0563_210_145_20170313_00129.jpg

LM Start	6.75	Rating **	U	Issue No.	145
LM End	6.79	Issue Type +	Ma	Location *	LS
Category	Earthen Levee			GPS Latitude/Longitude	
				Start	End
Item	Trim / Thin Trees			38.175219 °	38.174743 °
				-121.580053 °	-121.580016 °
DWR ID	DWR_RD0563_01_s_2014_145				
Comment Code					
T2 : Thin trees to allow visibility of the ground and room to flood fight.					
Inspector Comment					
Untrimmed trees blocking view of landward toe.

Looking southeast at dense vegetation on landward slope and toe.

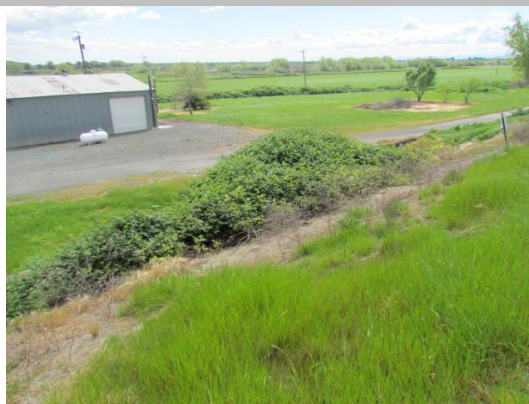
Photo 1 of 1 : SP_2017_RD0563_210_151_20170313_00133.jpg

LM Start	7.06	Rating **	U	Issue No.	151
LM End	7.14	Issue Type +	Ma	Location *	LS
Category	Earthen Levee			GPS Latitude/Longitude	
				Start	End
Item	Vegetation			38.170827 °	38.169705 °
				-121.579902 °	-121.580355 °
DWR ID	DWR_RD0563_01_f_2014_151				
Comment Code					
V2 : Remove the wild growth other than native grasses from the levee slopes.					
Inspector Comment					
Dense berryvines at landward toe.

Looking southeast at dense vegetation at landward toe.

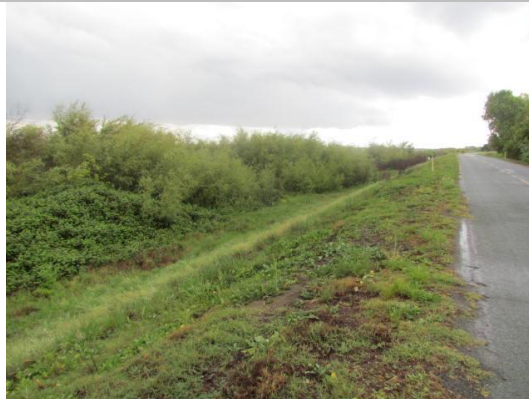
Photo 1 of 1 : SP_2017_RD0563_210_27_20170313_00023.jpg

LM Start	7.42	Rating **	U	Issue No.	27
LM End	7.47	Issue Type +	Ma	Location *	LS
Category	Earthen Levee			GPS Latitude/Longitude	
				Start	End
Item	Vegetation			38.165981 °	38.165273 °
				-121.582394 °	-121.582593 °
DWR ID	DWR_RD0563_01_s_2015_27				
Comment Code					
V2 : Remove the wild growth other than native grasses from the levee slopes.					
Inspector Comment					
Dense vegetation at landward toe.

Looking southeast at dense vegetation within landward right away.

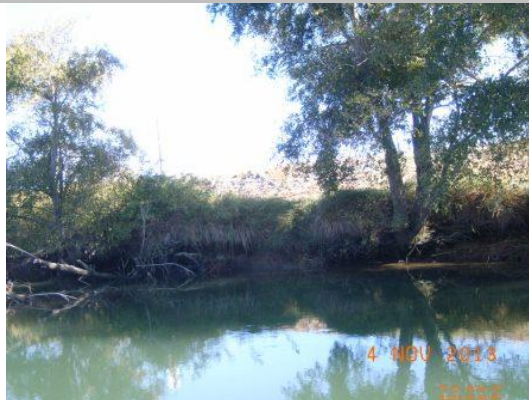
Photo 1 of 1 : SP_2017_RD0563_210_53_20170313_00043.jpg

LM Start	7.53	Rating **	U	Issue No.	53
LM End	7.80	Issue Type +	Ma	Location *	WS
Category	Supplemental			GPS Latitude/Longitude	
				Start	End
Item	2015 USACE Erosion Survey, DRAFT			38.164462 °	38.160888 °
				-121.583092 °	-121.584807 °
DWR ID	DWR_RD0563_01_s_2016_53				
Comment Code					
Inspector Comment					
1997 - Pocket erosion at upstream end and into the levee toe under the Alder trees. 2003 - New brush boxes with wattles on bank. 2004 - No brush boxes. 2005 - Site extended from the downstream side of the bridge. Whole bank is vertical. 2010 - Some minor new erosion. 2011 - Site upgraded to CRITICAL. New erosion pockets throughout the site. Sites 4.5, and 4.6 were combined. 2015: Last observed in 2013. [2015 Site ID: GEO_4-5_L]

USACE 2013 Photo #1

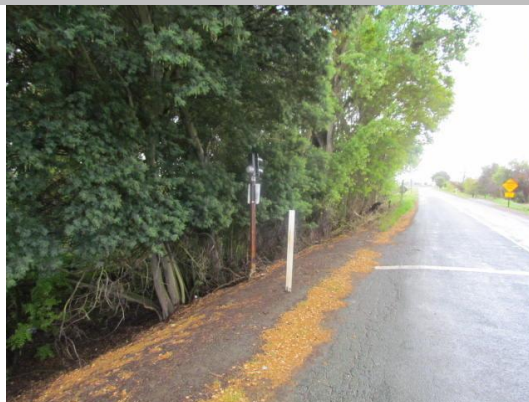
Photo 1 of 1 : SP_2017_RD0563_210_29_20170313_00025.jpg

LM Start	7.74	Rating **	M	Issue No.	29
LM End	7.78	Issue Type +	Ma	Location *	LS
Category	Earthen Levee			GPS Latitude/Longitude	
				Start	End
Item	Trim / Thin Trees			38.161607 °	38.161092 °
				-121.584258 °	-121.584470 °
DWR ID	DWR_RD0563_01_s_2012_29				
Comment Code					
T1 : Trim trees to at least five feet above ground level.					
Inspector Comment					
Dense (untrimmed) trees on landward slope.

Looking southeast at dense trees on landward slope and toe.

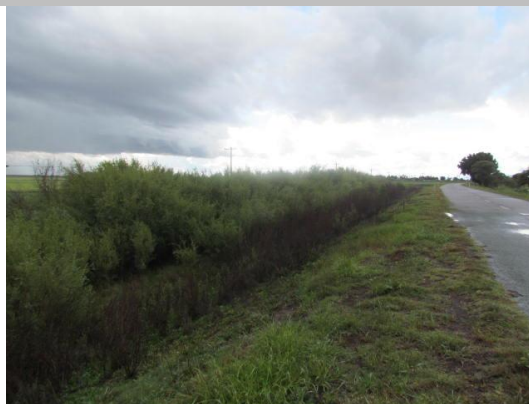
Photo 1 of 5 : SP_2017_RD0563_210_90_20170313_00087.jpg

LM Start	7.80	Rating **	U	Issue No.	90
LM End	7.82	Issue Type +	Ma	Location *	LS
Category	Earthen Levee			GPS Latitude/Longitude	
				Start	End
Item	Vegetation			38.160800 °	38.160487 °
				-121.584598 °	-121.584717 °
DWR ID	DWR_RD0563_01_s_2012_90				
Comment Code					
V2 : Remove the wild growth other than native grasses from the levee slopes.					
Inspector Comment					
Berryvines and willows on landside toe.

Looking southeast at dense vegetation at landward toe. (Spring 2015)

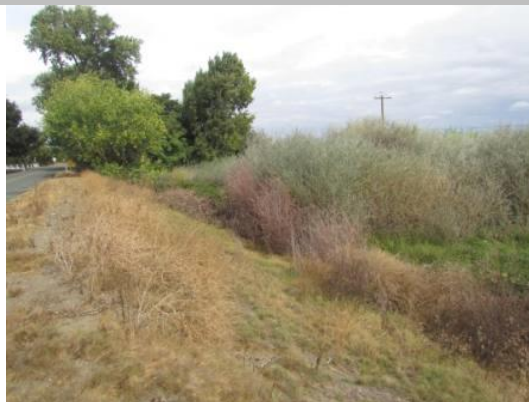
Photo 2 of 5 : SP_2017_RD0563_210_90_20170313_00088.jpg

Looking northeast at dense vegetation on landside toe.

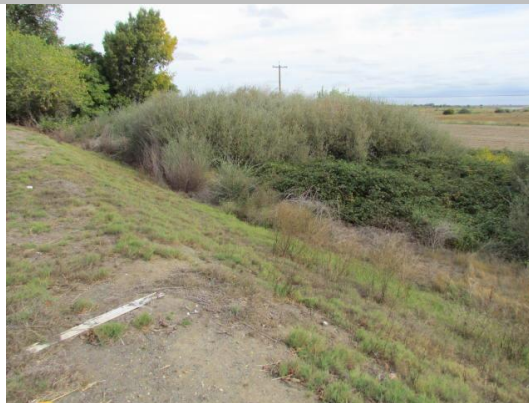
Photo 4 of 5 : SP_2017_RD0563_210_90_20170313_00090.jpg

LM Start	7.80	Rating **	U	Issue No.	90 (cont)	
LM End	7.82	Issue Type +	Ma	Location *	LS	
Category	Earthen Levee			GPS Latitude/Longitude		
				Start		End
Item	Vegetation			38.160800 °		38.160487 °
				-121.584598 °		-121.584717 °
DWR ID	DWR_RD0563_01_s_2012_90					
Comment Code						
V2 : Remove the wild growth other than native grasses from the levee slopes.						
Inspector Comment						
Berryvines and willows on landside toe.

Looking northeast at dense vegetation on landside toe. (2012 Fall Inspection)

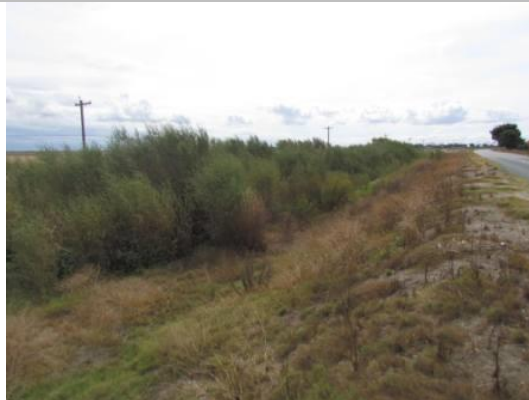
Photo 5 of 5 : SP_2017_RD0563_210_90_20170313_00091.jpg

Looking southwest at dense vegetation on landside toe.

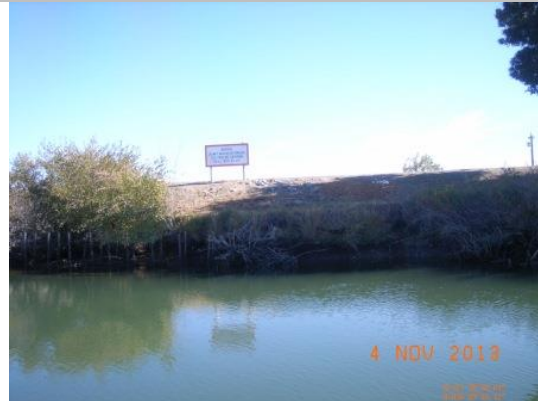
Photo 1 of 1 : SP_2017_RD0563_210_13_20170313_00014.jpg

Comment Code					
Inspector Comment					
1997 - Pockets of erosion into the levee toe. 1999 - Minor rock riprap and willow bundles place in a couple of spots. 2001 - Staked, low fascine walls at bankline. 2003 - Small unprotected pockets still eroding. 2004 - Numerous brush boxes, some falling apart, some with new bundles. 2005 - Some new brush boxes installed; some boxes are empty. Levee slope and banks still look bad with pocket scallops into the levee slopes. 2011 - Erosion continues and the number of pockets is increasing. 2013 - Some of the downstream end was repaired by the RD. 2015: Last observed in 2013. [2015 Site ID: GEO_4-3_L]

USACE 2013 Photo #1

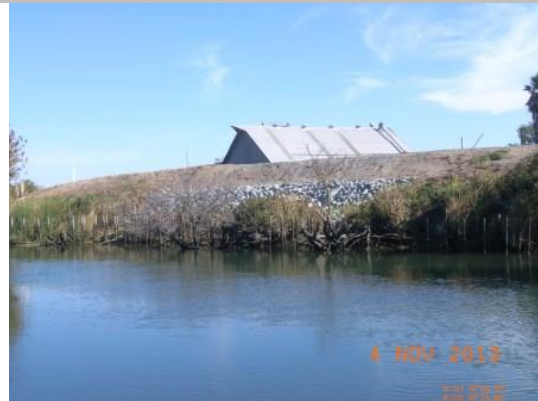
Photo 1 of 1 : SP_2017_RD0563_210_40_20170313_00033.jpg

LM Start	8.12	Rating **	M	Issue No.	40
LM End	8.59	Issue Type +	Ma	Location *	WS
Category	Supplemental			GPS Latitude/Longitude	
				Start	End
Item	2015 USACE Erosion Survey, DRAFT			38.156987 °	38.152919 °
				-121.587427 °	-121.591129 °
DWR ID	DWR_RD0563_01_s_2016_40

Comment Code					
Inspector Comment					
1997 - Pockets of erosion into the levee at the water line. Alders are being undercut and rotating out into the channel. Damaged rock at upstream end. 2000 - New minor erosion. 2001 - Staked low fascine walls at bankline. 2002 - New "Brush Boxes" along the bank toe. 2003 - New erosion pockets in the middle of the site. 2005 - Some new bundles in the brush boxes. 2011 - Site upgraded to CRITICAL. Significant new erosion. Sites 3.6, 3.7, 3.71, and 4.0 were combined. 2012 - Rock has been placed in some of the erosion pockets since last year, however site remains critical. 2013 - Site no longer critical. The worst pockets were filled with rock by the local RD. 2015: Last observed in 2013. [2015 Site ID: GEO_3-8_L]

USACE 2013 Photo #1

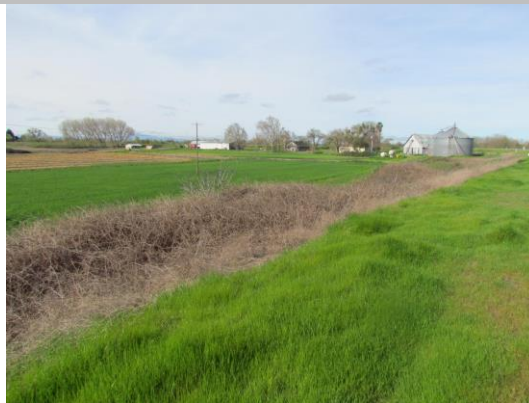
Photo 1 of 2 : SP_2017_RD0563_210_767_20170316_00259.jpg

LM Start	8.18	Rating **	U	Issue No.	767	
LM End	8.18	Issue Type +	Ma	Location *	LS	
Category	Earthen Levee			GPS Latitude/Longitude		
				Start		End
Item	Vegetation			38.156878 °		38.156878 °
				-121.588505 °		-121.588505 °
DWR ID	DWR_RD0563_01_s_2015_767					
Comment Code						
V2 : Remove the wild growth other than native grasses from the levee slopes.						
Inspector Comment						
Dead dense vegetation blocking landward toe.

Looking south at dead vines at landward toe. (Spring 2017)

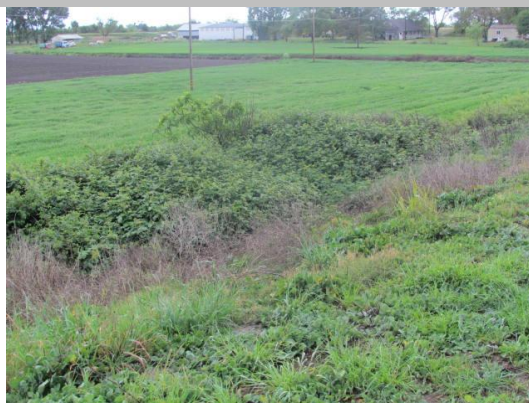
Photo 2 of 2 : SP_2017_RD0563_210_767_20170313_00151.jpg

Looking east at dense wild vines at landward toe. (Fall 2016)

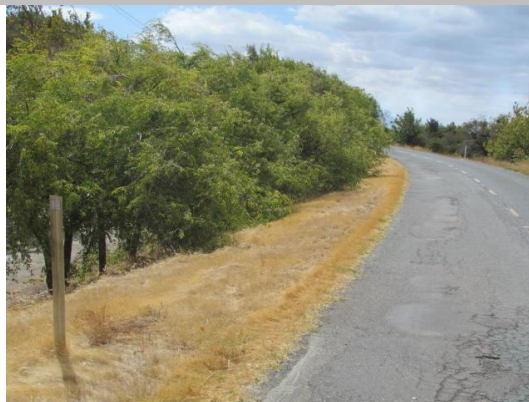
Photo 1 of 1 : SP_2017_RD0563_210_31_20170313_00026.jpg

LM Start	8.38	Rating **	U	Issue No.	31
LM End	8.41	Issue Type +	Ma	Location *	LS
Category	Earthen Levee			GPS Latitude/Longitude	
				Start	End
Item	Trim / Thin Trees			38.155974 °	38.155543 °
				-121.591452 °	-121.591595 °
DWR ID	DWR_RD0563_01_s_2012_31				
Comment Code					
T1 : Trim trees to at least five feet above ground level.					
Inspector Comment

Looking southeast at untrimmed trees on landward slope and toe.

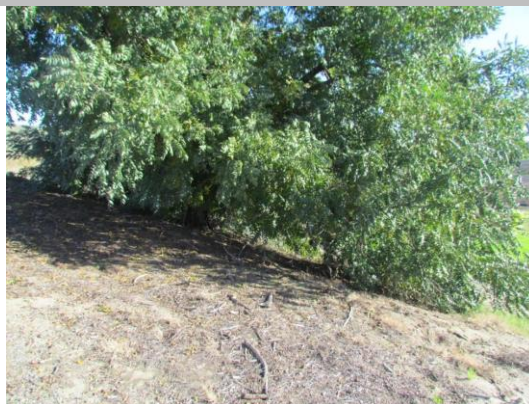
Photo 1 of 1 : SP_2017_RD0563_210_768_20170313_00152.jpg

LM Start	9.25	Rating **	U	Issue No.	768
LM End	9.25	Issue Type +	Ma	Location *	LS
Category	Earthen Levee			GPS Latitude/Longitude	
				Start	End
Item	Trim / Thin Trees			38.145897 °	38.145897 °
				-121.588203 °	-121.588203 °
DWR ID	DWR_RD0563_01_s_2015_768				
Comment Code					
T1 : Trim trees to at least five feet above ground level.					
Inspector Comment

Looking at untrimmed tree on landward slope.

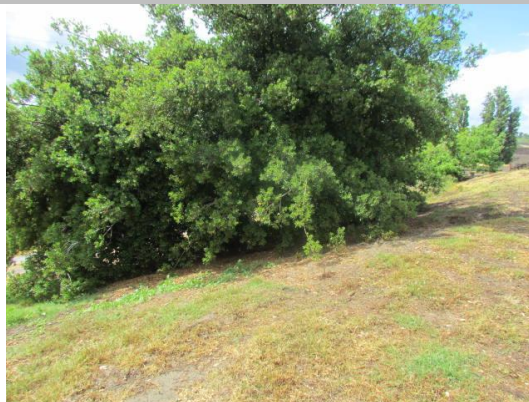
Photo 1 of 1 : SP_2017_RD0563_210_98_20170313_00099.jpg

LM Start	9.28	Rating **	U	Issue No.	98
LM End	9.28	Issue Type +	Ma	Location *	LS
Category	Earthen Levee			GPS Latitude/Longitude	
				Start	End
Item	Trim / Thin Trees			38.145825 °	38.145825 °
				-121.588807 °	-121.588807 °
DWR ID	DWR_RD0563_01_s_2013_98				
Comment Code					
T1 : Trim trees to at least five feet above ground level.					
Inspector Comment

Looking southeast at untrimmed trees on landward slope.

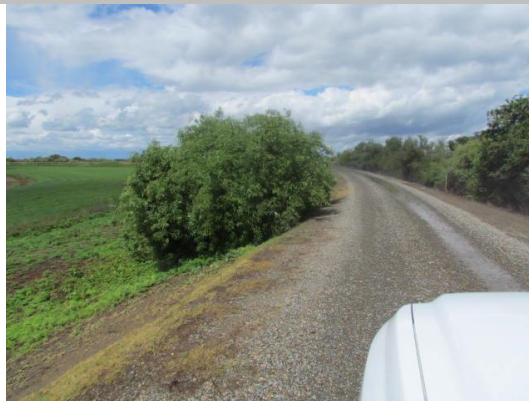
Photo 1 of 1 : SP_2017_RD0563_210_36_20170313_00030.jpg

LM Start	9.64	Rating **	M	Issue No.	36
LM End	9.64	Issue Type +	Ma	Location *	LS
Category	Earthen Levee			GPS Latitude/Longitude	
				Start	End
Item	Vegetation			38.149790 °	38.149790 °
				-121.592788 °	-121.592788 °
DWR ID	DWR_RD0563_01_s_2012_36				
Comment Code					
V4 : Elderberries are blocking visibility and flood fight capability.					
Inspector Comment					
Vegetation blocking view of levee slope.

Looking south at elderberry on landward slope.

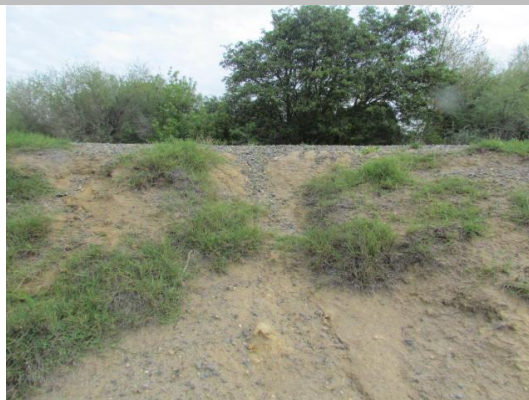
Photo 1 of 2 : SP_2017_RD0563_210_99_20170313_00100.jpg

LM Start	9.65	Rating **	M	Issue No.	99
LM End	9.65	Issue Type +	Ma	Location *	LS
Category	Earthen Levee			GPS Latitude/Longitude	
				Start	End
Item	Erosion / Bank Caving			38.149905 °	38.149905 °
				-121.592910 °	-121.592910 °
DWR ID	DWR_RD0563_01_s_2013_99				
Comment Code					
E1 : Note and monitor erosion site.					
Inspector Comment					
Finger erosion on landward shoulder and slope.

Looking west at minor erosion on landward shoulder and slope.

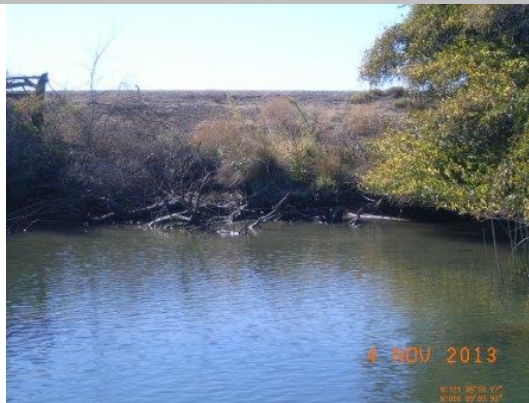
Photo 1 of 1 : SP_2017_RD0563_210_41_20170313_00034.jpg

LM Start	9.73	Rating **	M	Issue No.	41
LM End	9.90	Issue Type +	Ma	Location *	WS
Category	Supplemental			GPS Latitude/Longitude	
				Start	End
Item	2015 USACE Erosion Survey, DRAFT			38.150820 °	38.150647 °
				-121.593650 °	-121.596858 °
DWR ID	DWR_RD0563_01_s_2016_41				
Comment Code					
Inspector Comment					
1997 - Erosion pockets into the toe of the levee. 2001 - Staked low fascine walls at the bankline. 2004 - Numerous "Brush Boxes." 2005 - Some new bundles in the brush boxes. 2012 - Site extended downstream to account for new bank sloughing. 2013 - Some rock added to the upstream end by the local RD. 2015: Last observed in 2013. [2015 Site ID: GEO_2-5_L]

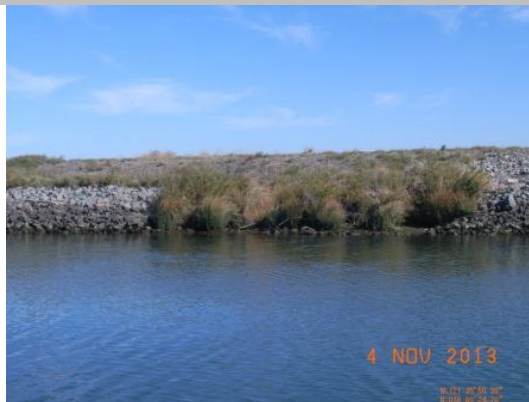
Photo 1 of 1 : SP_2017_RD0563_210_43_20170313_00036.jpg

LM Start	10.45	Rating **	M	Issue No.	43
LM End	10.74	Issue Type +	Ma	Location *	WS
Category	Supplemental			GPS Latitude/Longitude	
				Start	End
Item	2015 USACE Erosion Survey, DRAFT			38.143519 °	38.139918 °
				-121.599677 °	-121.596986 °
DWR ID	DWR_RD0563_01_s_2016_43				
Comment Code					
Inspector Comment					
1997 - Old damaged rock riprap along the toe. 1999 - Downstream end (400 ft) repaired with rock. 2002 - New rock/concrete rubble section on the downstream end. 2004 - Small pocket repairs at the downstream end. 2005 - Some new bundles in the brush boxes. 2012 - Some rock has been placed in last year. 2015: Last observed in 2013. [2015 Site ID: GEO_1-7_L]

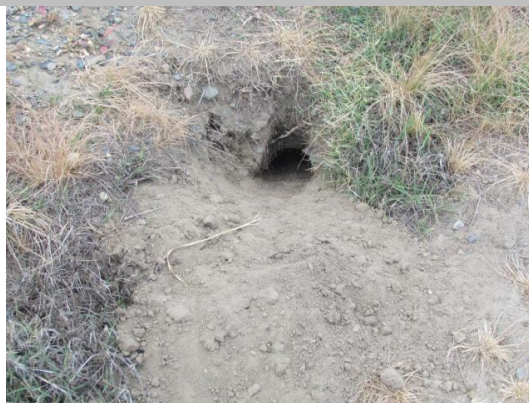
Photo 1 of 5 : SP_2017_RD0563_210_77_20170313_00068.jpg

LM Start	10.54	Rating **	U	Issue No.	77
LM End	10.64	Issue Type +	Ma	Location *	LS
Category	Earthen Levee			GPS Latitude/Longitude	
				Start	End
Item	Animal Control			38.142537 °	38.141362 °
				-121.598535 °	-121.597598 °
DWR ID	DWR_RD0563_01_s_2012_77				
Comment Code					
A1 : Exterminate rodents and backfill and compact or grout burrows.					
Inspector Comment					
Several rodent holes and rodents noted at this site.

Looking at typical rodent hole on landward slope. (Spring 2016)

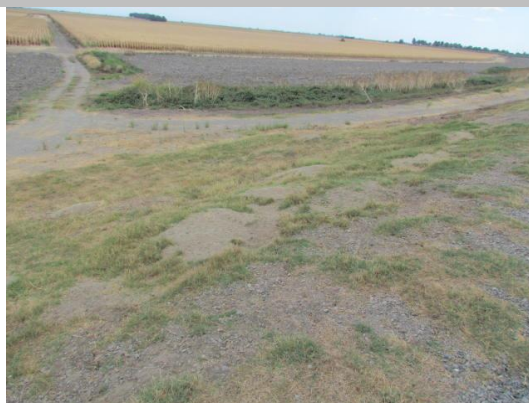
Photo 2 of 5 : SP_2017_RD0563_210_77_20170313_00069.jpg

Looking southeast at several rodent holes on landward slope.

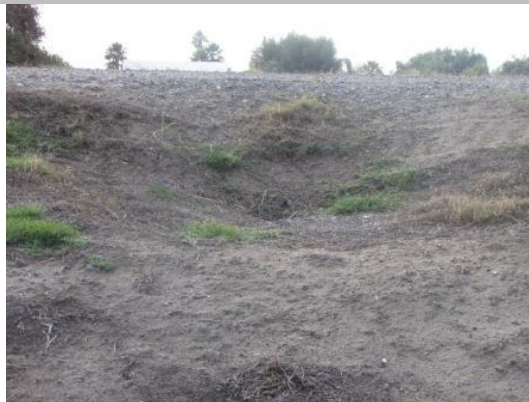
Photo 3 of 4 : SP_2017_RD0563_210_76_20170313_00066.jpg

LM Start	10.59	Rating **	M	Issue No.	76
LM End	10.59	Issue Type +	Ma	Location *	LS
Category	Earthen Levee			GPS Latitude/Longitude	
				Start	End
Item	Slope Stability			38.141940 °	38.141940 °
				-121.598033 °	-121.598033 °
DWR ID	DWR_RD0563_01_s_2012_76				
Comment Code					
S1 : Repair slope instability.					
Inspector Comment					
Deep depression on landside shoulder and slope; possible pipe collapse.

Looking west at depression on landside shoulder and slope from landside toe.

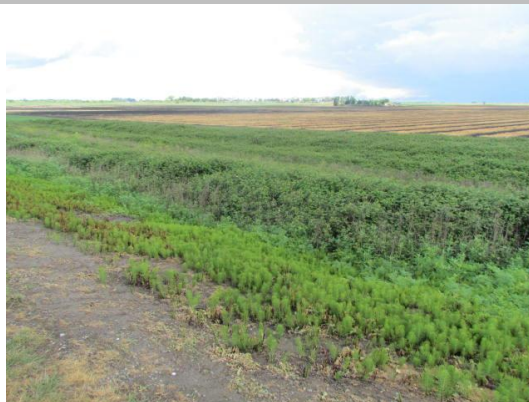
Photo 1 of 3 : SP_2017_RD0563_210_100_20170313_00102.jpg

LM Start	10.67	Rating **	U	Issue No.	100
LM End	10.81	Issue Type +	Ma	Location *	LS
Category	Earthen Levee			GPS Latitude/Longitude	
				Start	End
Item	Vegetation			38.140886 °	38.139079 °
				-121.597280 °	-121.596214 °
DWR ID	DWR_RD0563_01_s_2013_100				
Comment Code					
V2 : Remove the wild growth other than native grasses from the levee slopes.					
Inspector Comment					
Wild rose or grape vines on landward slope and toe.

Looking northeast at dense vegetation at landward toe. (Spring 2015)

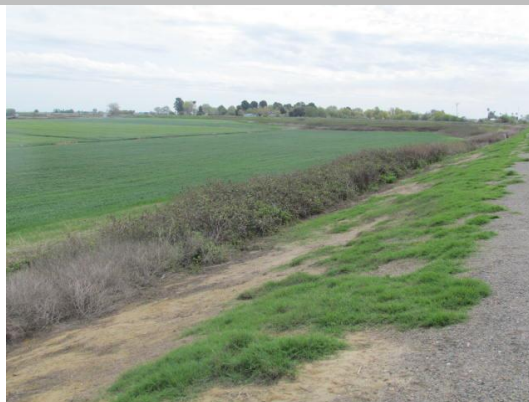
Photo 2 of 3 : SP_2017_RD0563_210_100_20170313_00103.jpg

Looking south at dense vegetation at landward toe. (Fall 2014)

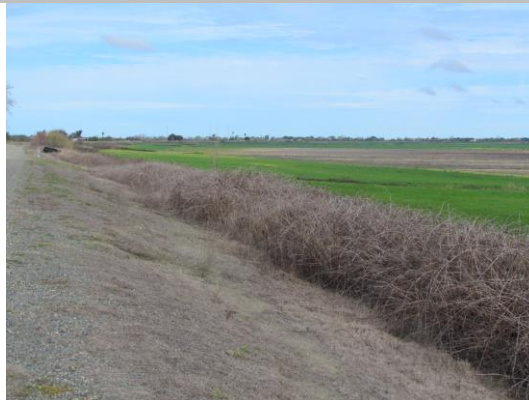
Photo 1 of 2 : SP_2017_RD0563_210_770_20170316_00262.jpg

LM Start	11.01	Rating **	U	Issue No.	770
LM End	12.00	Issue Type +	Ma	Location *	LS
Category	Earthen Levee			GPS Latitude/Longitude	
				Start	End
Item	Vegetation			38.136623 °	38.130739 °
				-121.594216 °	-121.579678 °
DWR ID	DWR_RD0563_01_s_2015_770				
Comment Code					
V2 : Remove the wild growth other than native grasses from the levee slopes.					
Inspector Comment					
Dead dense veg (wildroses) at landward toe.

Looking northeast at dead vines at landward toe. (Spring 2017)

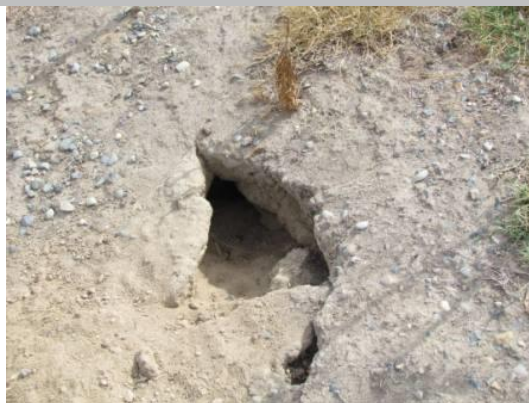
Photo 1 of 3 : SP_2017_RD0563_210_91_20170313_00092.jpg

LM Start	11.45	Rating **	M	Issue No.	91
LM End	11.45	Issue Type +	Ma	Location *	LS
Category	Earthen Levee			GPS Latitude/Longitude	
				Start	End
Item	Animal Control			38.131943 °	38.131943 °
				-121.588912 °	-121.588912 °
DWR ID	DWR_RD0563_01_s_2012_91				
Comment Code					
A3 : No rodents visible, but rodent burrows visible; need to backfill and compact or grout burrows.					
Inspector Comment

Looking east at rodent hole on landside slope.

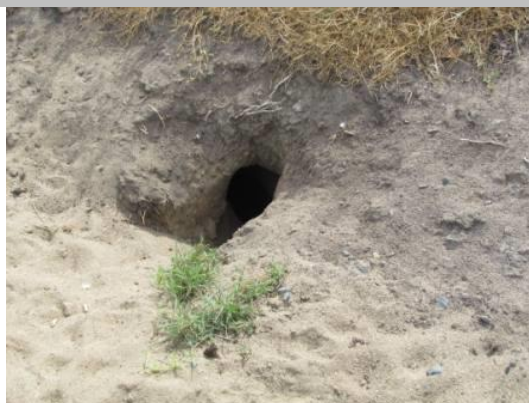
Photo 2 of 3 : SP_2017_RD0563_210_91_20170313_00093.jpg

Looking west at rodent hole on landside slope.

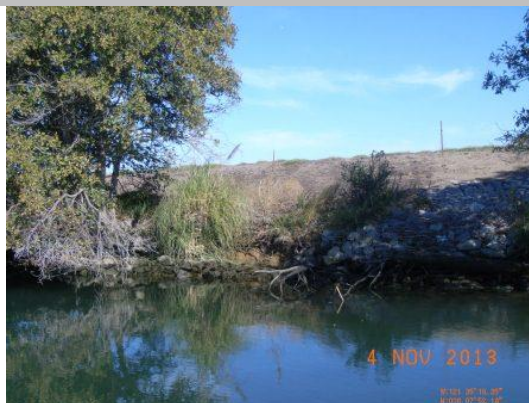
Photo 1 of 1 : SP_2017_RD0563_210_42_20170313_00035.jpg

Comment Code					
Inspector Comment					
1997 - Erosion pockets into the levee toe. 1999 - Some small pockets fixed with rock riprap. 2002 - New "brush boxes" along the bank toe. 2005 - Brush boxes are empty. Some pockets are filled with new stone. 2006 - Some new rock at the downstream end (~100 ft long). Several small pockets of new rock in scallops. Brush boxes in poor to fair condition. 2010 - Site looks a little worse, some toe rock but still has erosion scars at lower to mid slope. 2011 - Site upgraded to CRITICAL. Significant new erosion. Erosion scallops are vertical and almost the height of the levee. 2012 - Rock has been placed in some of the erosion scallops and therefore the site is no longer critical. 2013 - Site shortened site. The downstream half of site was repaired by RD. Pipe no longer in site limits. 2015: Last observed in 2013. [2015 Site ID: GEO_0-3_L]

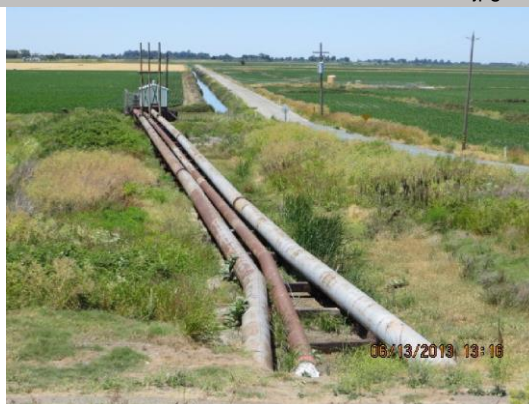
Photo 1 of 3 : UCIP_SP_2017_15027_24731.jpg

LM Start	12.00	Rating **	A/W	Issue No.	804
LM End	12.00	Issue Type +	Ma	Location *	WS
Category	Supplemental			GPS Latitude/Longitude	
				Start	End
Item	DWR UCIP LMA Responsibility			38.130726 °	38.130726 °
				-121.579646 °	-121.579646 °
DWR ID					
Comment Code					
Inspector Comment					
FS_ID:15027 DS_ID:20172 EP_NO: 11213 Repair Type: No Action Needed Crossing Status: Found UCIP Comments: FIELD_STRUCT_DESC: 20-inch steel drain pipe through the levee 1.0-foot below the crown. Pump on landward side. Siphon breaker on waterward shoulder (ABO No. 11213, 1971). Originally included in the 1954 O&M manual. FS Date: 6/13/2013

Pump and pipes off LS toe.

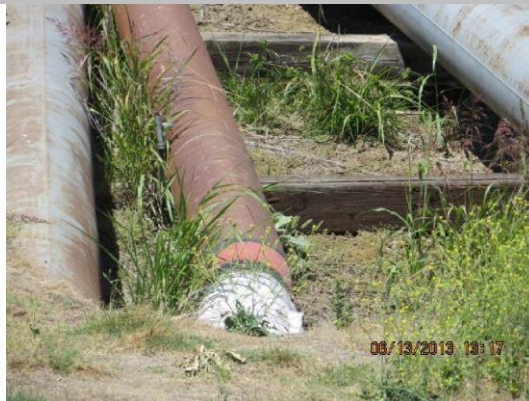
Photo 2 of 3 : UCIP_SP_2017_15027_24730.jpg

LM Start	12.00	Rating **	A/W	Issue No.	804 (cont)
LM End	12.00	Issue Type +	Ma	Location *	WS
Category	Supplemental			GPS Latitude/Longitude	
				Start	End
Item	DWR UCIP LMA Responsibility			38.130726 °	38.130726 °
				-121.579646 °	-121.579646 °
DWR ID					
Comment Code					
Inspector Comment					
FS_ID:15027 DS_ID:20172 EP_NO: 11213 Repair Type: No Action Needed Crossing Status: Found UCIP Comments: FIELD_STRUCT_DESC: 20-inch steel drain pipe through the levee 1.0-foot below the crown. Pump on landward side. Siphon breaker on waterward shoulder (ABO No. 11213, 1971). Originally included in the 1954 O&M manual. FS Date: 6/13/2013

20-inch pipe on LS toe.

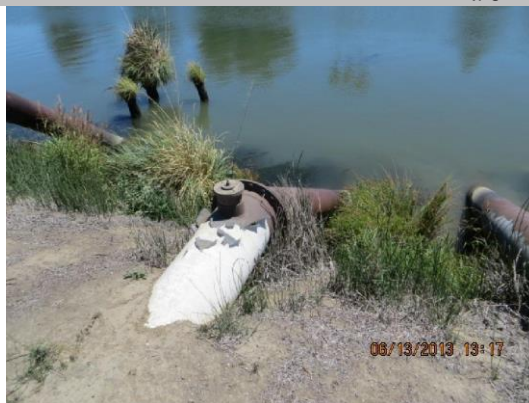
Photo 3 of 3 : UCIP_SP_2017_15027_24729.jpg

Pipe and siphon breaker on WS shoulder.
